PIC18F87J10 Family Rev. A2 Silicon Errata

The following silicon errata apply only to PIC18F87J10 family devices with these Device/Revision IDs:

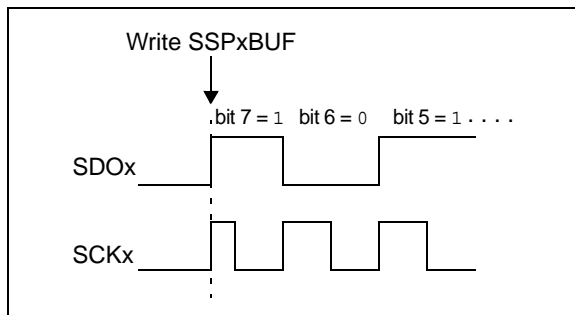
FIGURE 1: SCKx PULSE VARIATION USING TIMER2/2

6. Module: MSSP (SPI Mode)

When the SPI is using Timer2/2 as the clock source, a shorter than expected SCKx pulse may occur on the first bit of the transmitted/received data (Figure 1).

To avoid producing the short pulse, turn off Timer2 and clear the TMR2 register, load the SSPxBUF with the data to transmit and then turn Timer2 back on. Refer to Example 2 for sample code.
